**Summary of the Condition of the Organ Chamber and Tower Roofs
at St. Peter & St. Paul's Church, Wincanton**

The following is a summary of an inspection of the tower and organ chamber roof at St. Peter & St. Paul's church, Wincanton undertaken on 3rd October 2019.

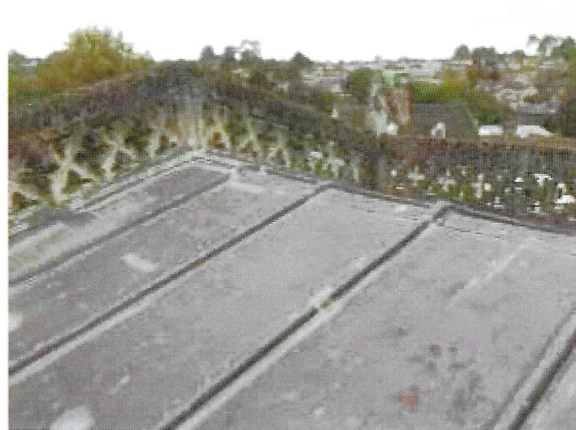
- 1.1 The organ chamber roof is formed of a pitched lead roof falling from a ridge to both the north and south. To the north it discharges into a lead parapet gutter and to the south into a lead gutter between the organ chamber and chancel slate roof.

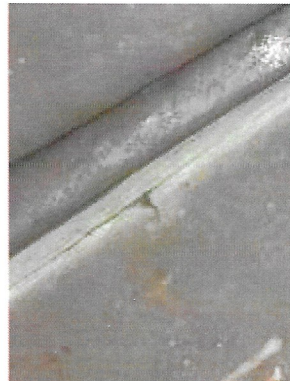
- 1.2 On the south slope there are numerous splits and patches to the leadwork. Several patches have split suggesting this is an ongoing problem. The bay sizes are too large for the code of lead which results in thermal movement within the lead causing the splits and damage. The patches are a mixture of welded lead repairs and bituminous patches.

- 1.12 The lead bays on the organ chamber roof and the adjoining gutters are oversized for the code of lead and this has resulted in thermal movement causing damaged and splitting to leadwork. In addition fixings to at least one lead bay on the north slope and the vertical lead bays into the southern gutter are failing resulting in the leadwork moving and laps between the lead bays becoming insufficient.

- 1.13 Regular patching of the leadwork appears to have prevented significant damage but the fact that several of the repairs have failed shows that the problem is ongoing and continued regular maintenance would be required.

- b) The second option would be to strip and recover the lead roof with new lead. This option would be more expensive and careful consideration of details such as flashings, parapet gutter depths and bay sizes would be required. However, if correctly done it would reduce any long term maintenance significantly. If the roof is being replaced, it would seem sensible to renew the lead gutter between the organ chamber and chancel and the vertical lead sheeting into this gutter at the same time.

- 1.18 Considering the condition of the roof coverings and the fact that the organ is situated below this roof, increasing the risks and possible expense of any leaks, I would recommend that the organ chamber roof is recovered along with works to the parapet stonework, removal of the chimney and replacement of the southern gutter.

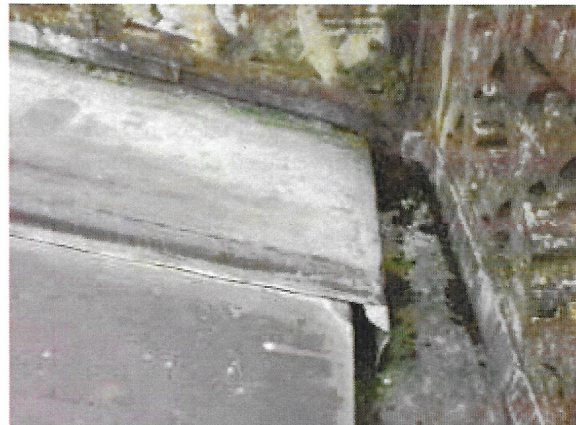
- 1.3 On the north slope the western bay lead has slipped down the roof slope.

- a) The first option would be to continue patching the roof on a regular basis and ensuring that regular inspections are undertaken to identify any splits or damage as swiftly as possible. Some initial repair work would be required to refix slipped bays. This approach would require regular and ongoing maintenance, probably on an annual basis.

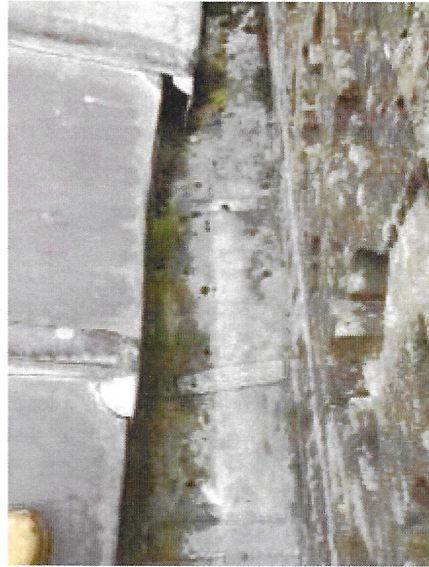
- 1.4 The northern parapet gutter is formed in one long bay of lead which has split and been patched in three locations. Again this is due to oversizing of the lead bays.

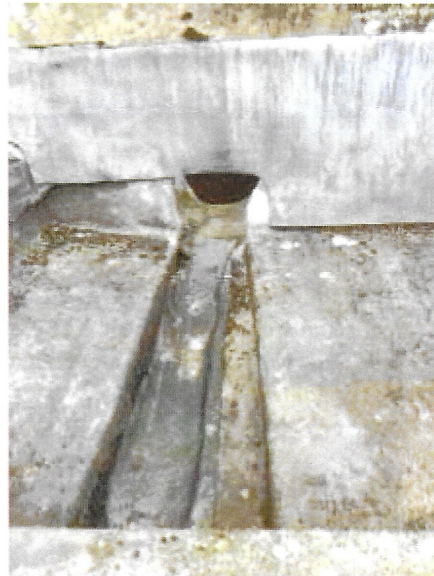
- 1.5 From the north gutter there is a lead chute outlet through the parapet wall. The lead has split and been patched with a modern coating.

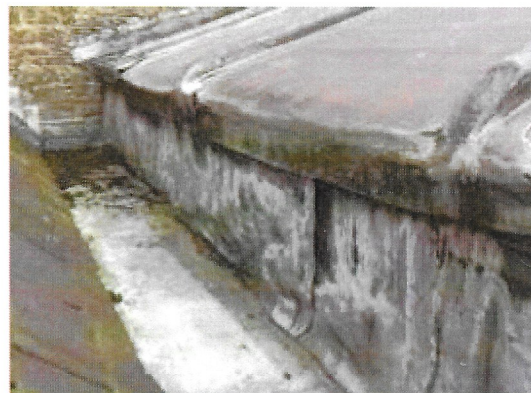
- 1.6 Between the eaves of the southern roof slope and the lead gutter on the chancel roof is vertical lead sheet cladding. Fixings to several of these lead sheets have failed causing the sheets to drop and sag.

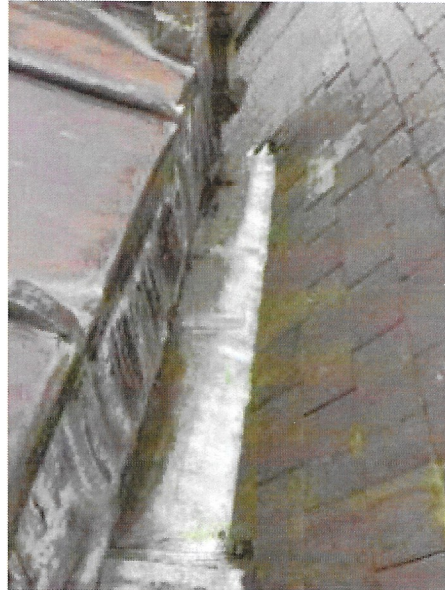
- 1.7 The lead gutter between the chancel and organ chamber is formed in two bays, the westernmost of which is extremely long for the code of lead. There are three patched splits on this bay.

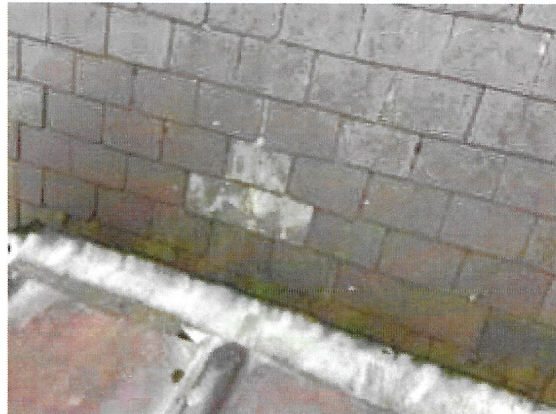
- 1.8 A number of slates have been damaged or come loose on the chancel at the junction with the gutter. Patching of the slates appears to have averted water penetration but several require refixing.

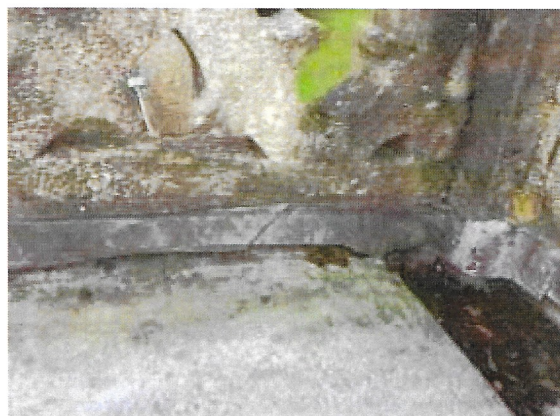
- 1.9 Flashings between the lead roof and parapets on the organ chamber roof have very poor upstands. The pierced decorative stone parapets severely restrict the available upstand. In several areas the pointing has failed and the flashings have become loose. The parapet gutter flashing has split in several places.

- 1.14 The upstand between the roof and the parapets is limited by the pierced decoration of the stonework and this has resulted in insufficient upstands and flashings in several areas. In addition several of the flashings have come loose in a number of locations and continued maintenance would again be required to ensure these junctions stay weathertight.

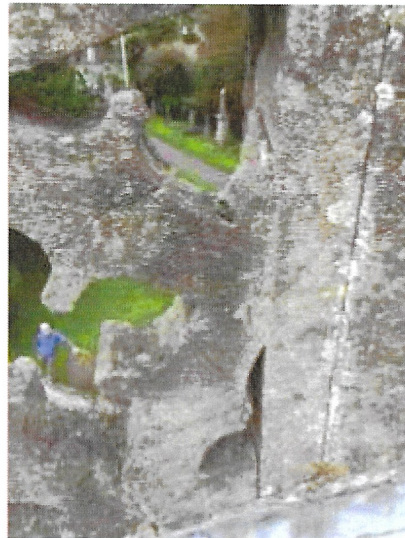
- 1.10 Whilst the parapet walls generally appear reasonably sound there are a number of areas of eroded or damaged stone.

- 1.15 The parapet stonework is generally sound but the carved decorative nature results in some elements being vulnerable. Some cracking and minor damage is visible and repairs are advisable to reduce the risk of loss.

- 1.16 There currently appear to be two options for repairing and maintaining the roof. Whichever option is chosen some repair to the parapet stonework would be advisable in the next five years or so.

- 1.17 It would also be economical to undertake conservation repairs to the parapet stonework and remove the redundant chimney to below the roof covering line whilst access for the roofing work is in place.

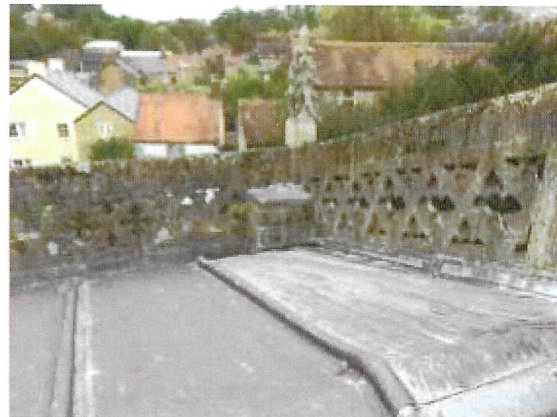
- 1.11 In the north-east corner of the parapet gutter there is an upstand to a redundant chimney stack with a lead cover. It may be possible to remove part of the chimney to below the roof line which will improve the detailing in this area.

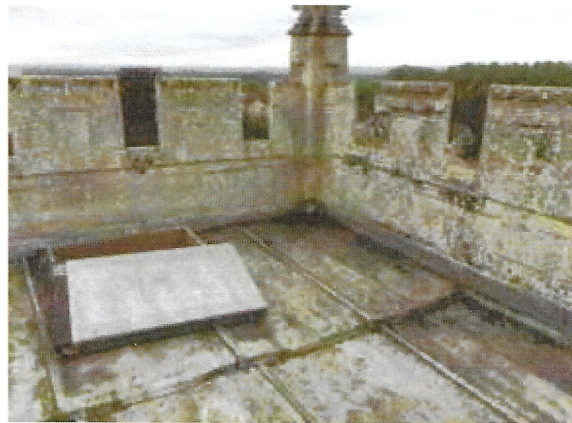
- 2.1 The tower roof is formed of two bays of lead falling to the north into a lead parapet gutter. The lead sheets have welted joints.

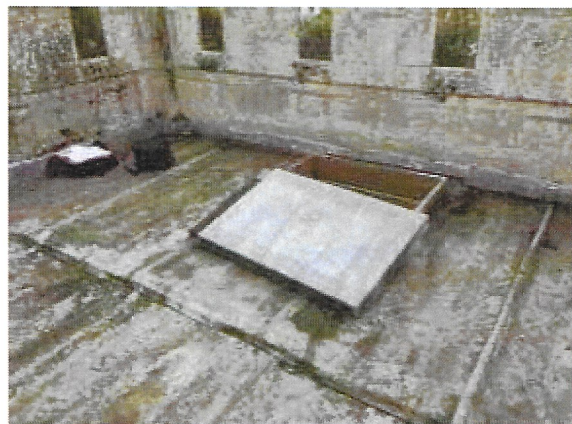
- 2.2 As with the organ chamber roof the leadwork to the tower roof has a number of splits that have been repaired and several sheets have slipped down the slope. Although the lead sheets are smaller than on the organ chamber they are still relatively large for their thickness and are of a reasonable age.

- 2.6 The leadwork on the roof is in fairly poor condition and elements of the detailing are poor.
- 2.7 While the lead could be repaired and patched this would be a relatively expensive exercise and is unlikely to add significant life to the coverings without regular maintenance.
- 2.8 Renewal of the lead coverings would allow improvement of detailing and save on long term maintenance. The height of the tower would make any works, repair or renewal, relatively expensive.
- 2.9 Therefore I would recommend that, subject to available funding, the tower roof should be recovered.

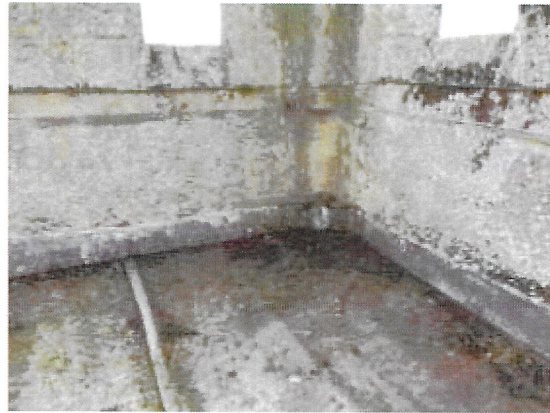
- 2.3 The lead flashings into the parapet wall are loose in several areas and mortar pointing has failed.

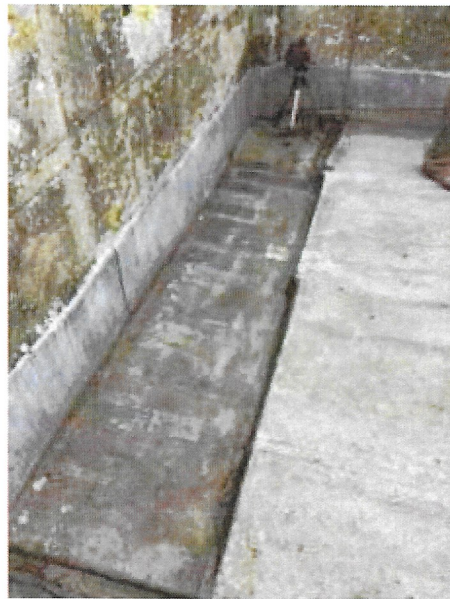
- 2.4 The lead parapet gutter to the north is in one long bay and has numerous splits and creases across the lead from thermal movement. The splits have been patched but due to the length of the lead bays it is likely that this problem will continue.

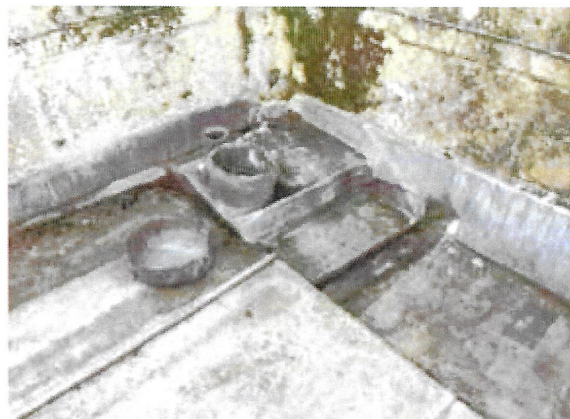
- 2.5 At the west end of the parapet gutter is a raised section that has a lead covering from a former flue outlet. The flue is now redundant and the liner/lead could be removed to below the roof line to improve/simplify the detailing in this corner..
